# SPECIFIC DEFECTS REPORT

Relating to front and rear  
extension work

XXXX

Chertsey,

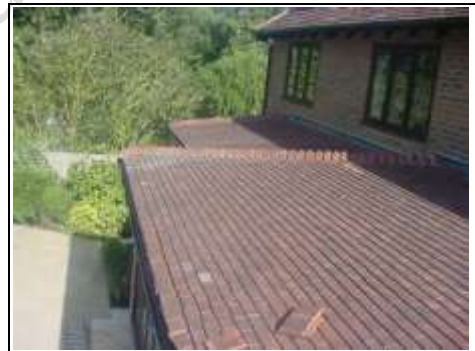
Due to the shallow pitch of this roof it has effectively a double roof. The top roof is tiled and the second under roof is in GRP (Glass reinforced plastic). We are concerned that the batons will not be suitably vented to avoid rot although they are likely to be treated batons we feel it would be more normal to carry out a cross battening and have a vent at the fascia board.

Currently the roof is allowing water into the property due to poor ridge detailing and gutter detailing. The valley gutters are starting to deteriorate.

Rear shallow pitched roof

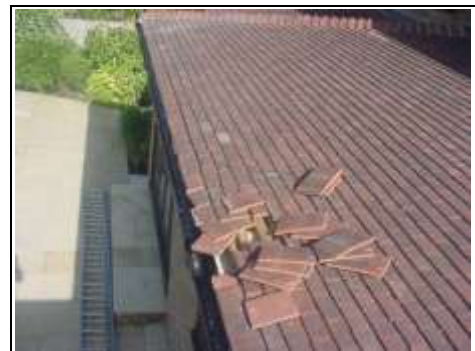
Roof opened up to expose the GRP layer below

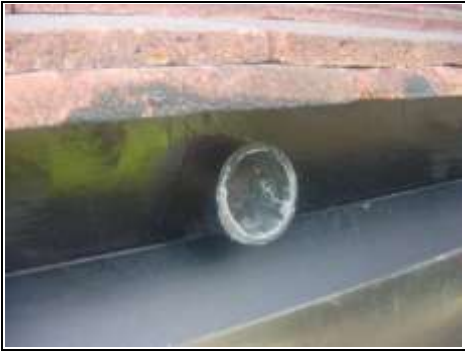
Poor gutter detailing

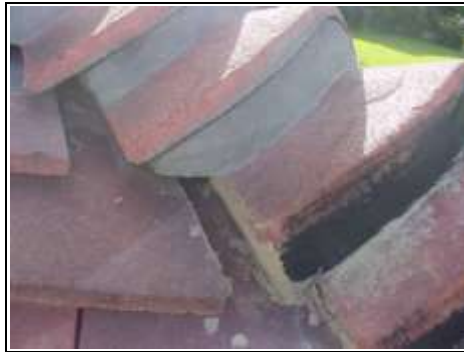
Poor ridge tiles detailing

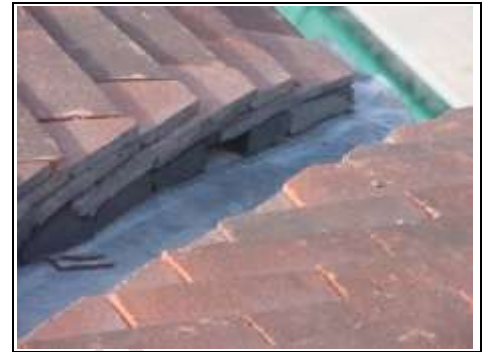
Valley gutter starting to deteriorate

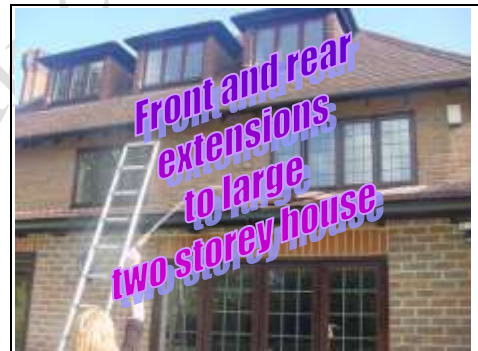
We sprayed the roof above the kitchen area and carried out a basic water test using electronic resistance meters internally.

This showed that the water is coming into the kitchen area and the dining room area.

Water test

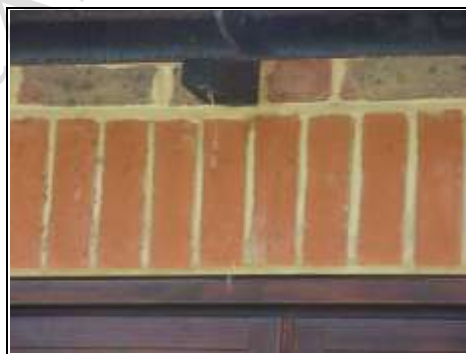
In addition water is travelling down the roof covering at missing the guttering transferring down the walls to the area beneath.

Water missing the gutters and coming down the wall

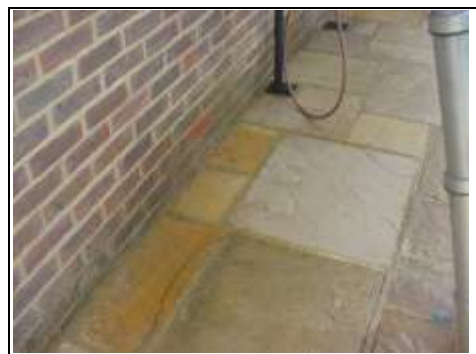
Water missing the gutters and coming down the walls

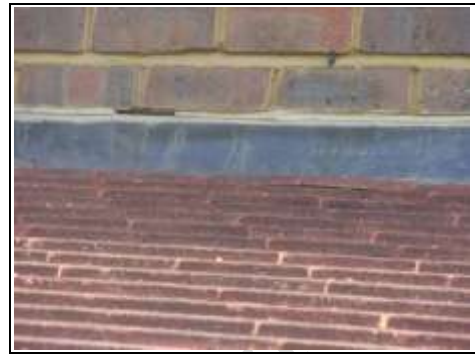
The lead flashing is bedded in a cement mortar. We note that there are areas where the surface mortar is coming away. The lead needs to be bedded to a depth of 25mm plus and ideally a mastic such as Plumbmate should be used as well as a lead plug.

Poor flashing detail not only is the flashing not high enough it has also not been bedded correctly. The cement fillet has come away from the lead flashing.

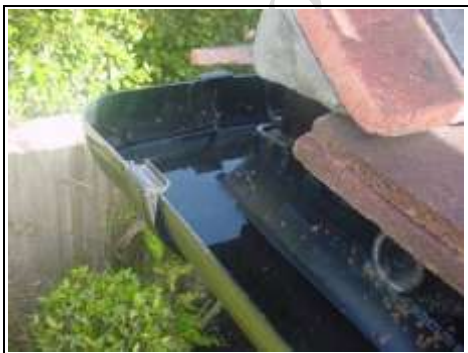
The guttering requires some work, the present layout we believe will lead to over flowing to the rear right hand side.

Gutters not clearing rainwater rear right hand corner, the fall also needs to be checked

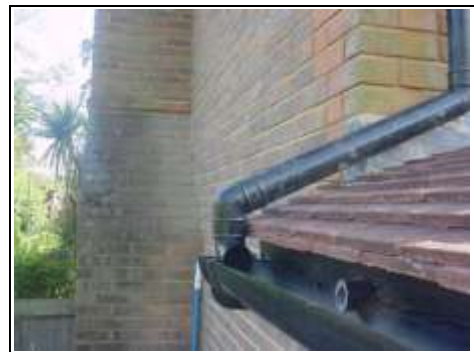
Overflowing to the rear right hand side

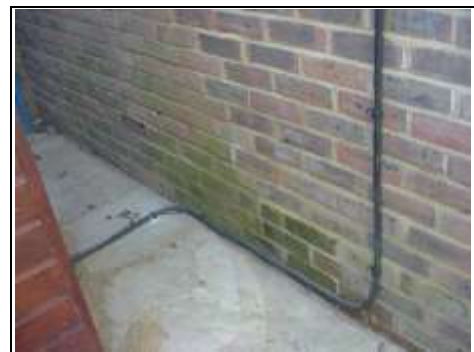
Result of overflowing

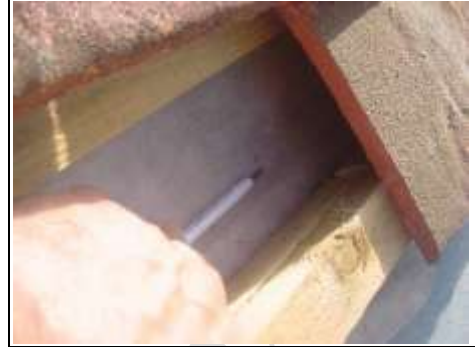
1.2.1) Return where the flat roof meets the pitched roof is not sufficient to stop water getting in particularly snow approximately 100mm above roof level.

Return on GRP to pen which is not high enough

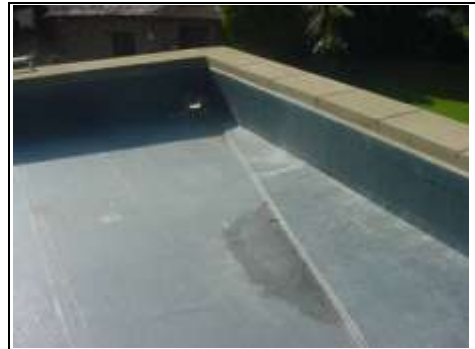
1.2.2) There is a lack of fall to the flat roof resulting in ponding. The flat roof is flat.

No fall on roof towards the hopper heads and downpipes

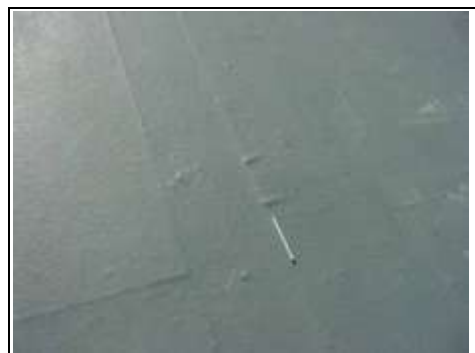
1.2.3) There is blistering to the flat roof.

Blistering in the flat roof

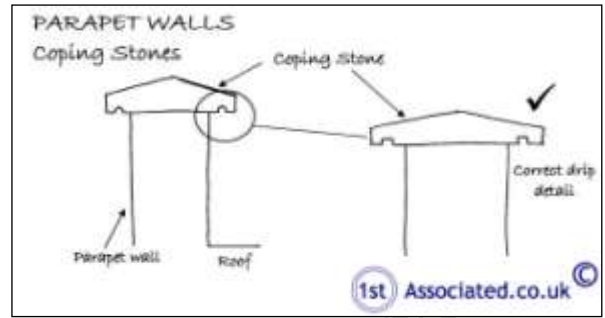
1.2.4) The coping stones do not have a drip detail and we are advised do not have a DPC (damp proof course) detail (the latter would only be a hundred per cent confirmed with the lifting of the coping stone).

Parapet walls coping stones

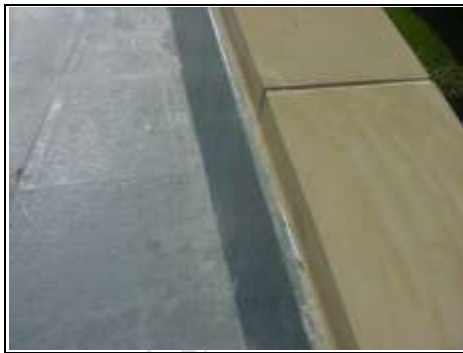
No drip detail to the coping stones

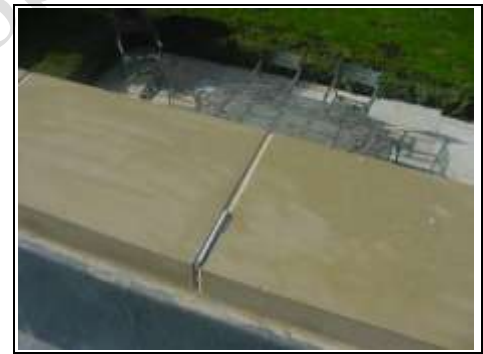
No DPC to coping stone a way around this would be capping the coping stone or removing it and adding a DPC and replacing it with a suitable coping stone.

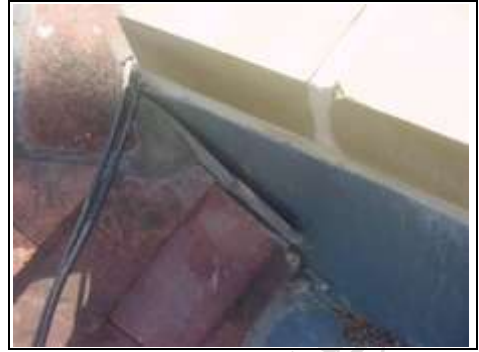
1.2.5) Not watertight lead detailing around the roof generally.

But specifically at the ends of the parapet wall and poor detailing into the hopper heads.

Poor lead gutter detail

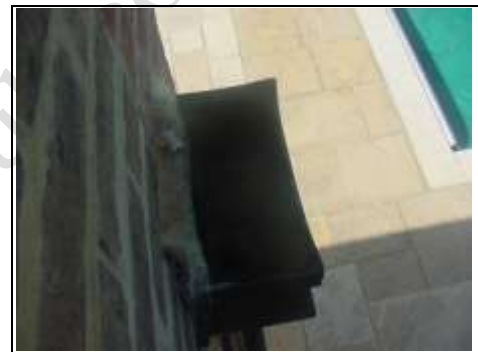
Junction detail to the hopper head not finished correctly

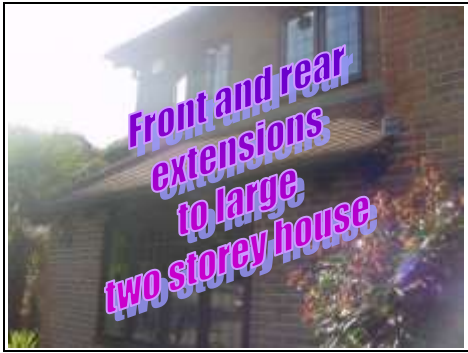
Where the new opening have been formed in the building the cavity tray typically needs to be installed to transfer any dampness that gets into the property from the walls back out.

Front view, has a cavity tray been installed?

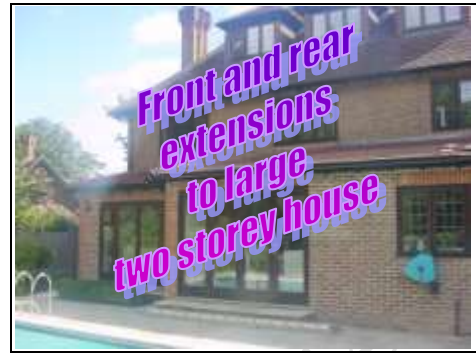
Has a cavity tray been installed under any of these windows?

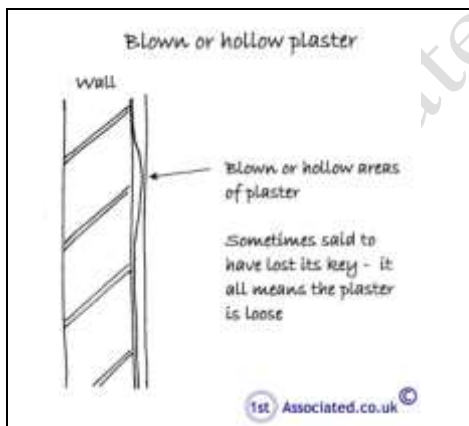
Dampness is getting into the structure both internally and externally and is visible in the form of efflorescence on the brickwork outside and internally although at present we did not notice any blown areas of plaster it will blow eventually.

Blown or hollow plaster

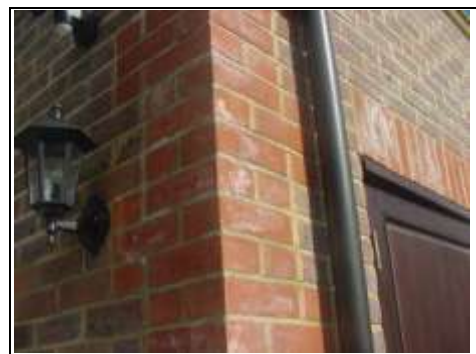
Efflorescent on the bricks

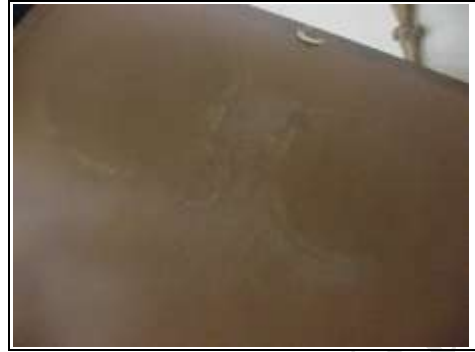
We could see that mould is visible to the back of the pictures which is an indication that there is a lot of dampness in this area.

Mould appearing on the back of the pictures in the lounge

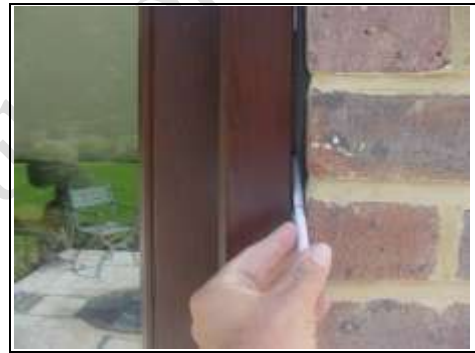
The perimeter detail to the windows has not had mastic applied. This will allow dampness in and heat out.

Mastic not applied

Mrs X has since had mastic replaced.

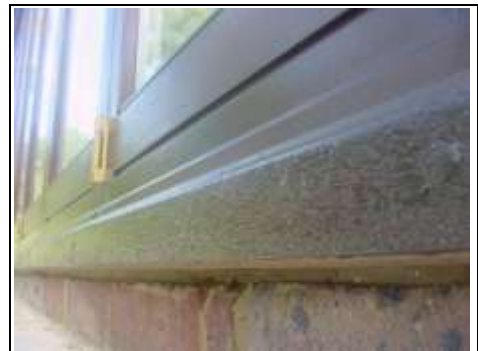
Wood under the window has not been stained

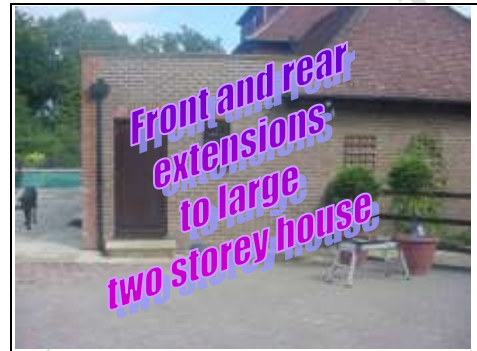
Left hand side view

We would recommend a running gulley to the left hand side (all directions given as you face the property) is added to the flat roof extension.

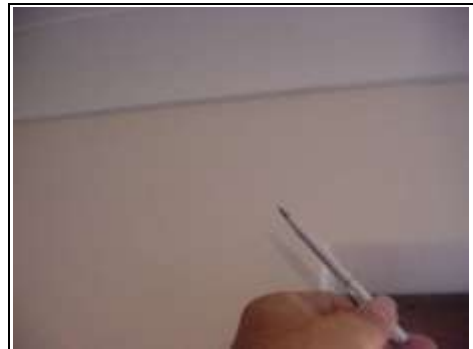
We are advised that the movement has occurred in the property when the walls were opened up. It is unknown if this movement that is visible in the plaster has caused structural damage to the property in the long term. Further investigations required.

Cracks visible in the adjacent bedroom

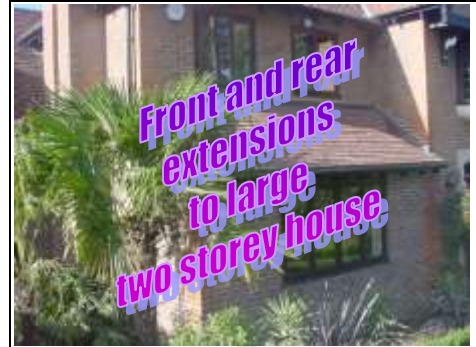
1.1.2) We are advised (by Mrs X) that the lead is not appropriately bedded 25mm into the joint.

1.1.3) The protective underlayer does not consistently lap into the gutters appropriately which would be good practice.

General view front extension

Item 1.1.2 is not visible and is in line with what we found to the rear roof.
