# SPECIFIC DEFECTS REPORT

Relating to front and rear  
extension work

XXXX

Chertsey,

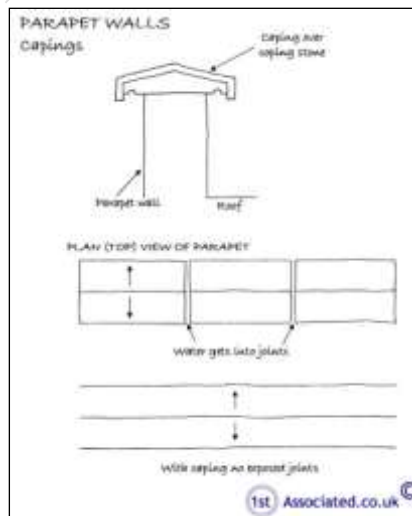
Parapet walls capings

No DPC to coping stone a way around this would be capping the coping stone or removing it and adding a DPC and replacing it with a suitable coping stone.

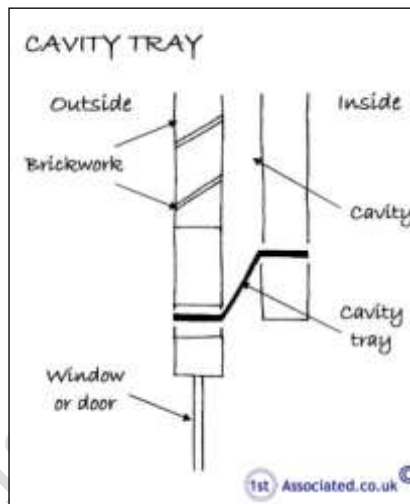
Cavity tray

Has a cavity tray been installed under any of these windows?

It is unknown if there is a cavity tray or a DPC (damp proof course) in the parapet wall and opening up into the main structure.
